Maryland Historical Trust

Maryland Inventory of Historic Properties Historic Bridge Inventory Maryland State Highway Administration Maryland Historical Trust

Name and SHA No. H 28 over Mill Brook

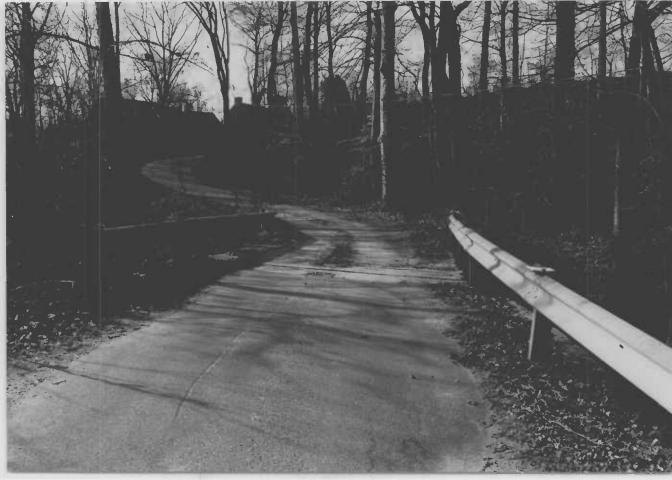
119-1879 HARFORD COUNTY MD JOHN TARQUINIO 27 JAIN 435 MARYLAND SHADSHA STATE HIGHWAY BRIDGE HES OVER HILL BROOK VIEW LODKING WEST ON HARMON CAURCH RD 114

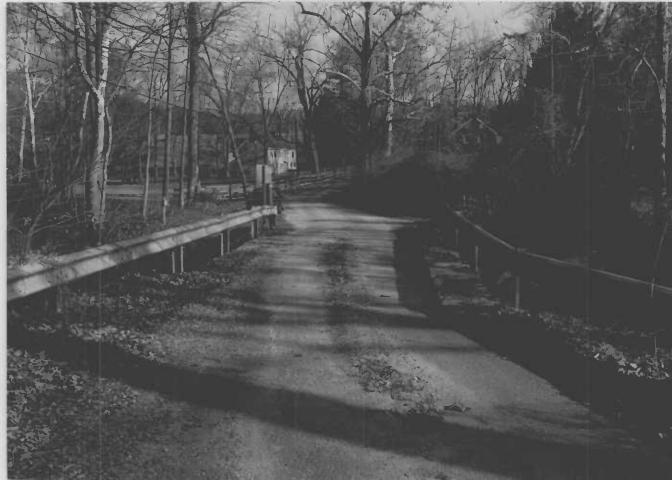
HA-1879 HARFORD COUNTY, MD VOHN TARQUINIO 27 JAN 1995 MARYCHIA SHOO SHA STATE HIGHWAY BRIDGE HZ8 OVER MILL BROOK VIEW LOOKING EAST ON HARMONY CHURCH RD 2/4

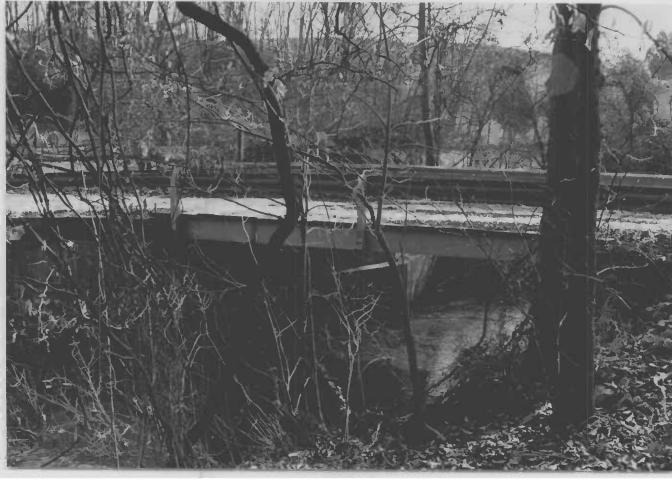
3/4

HP-1279 HAKFORD COVINIY MO VOHAL TARQUINIO 27 JAN 1995 MARY LAND SHIPS SIM STATE HIGHWAY BRIDGE HIZE OVER MILL VIEW LOOKINY SOUTH

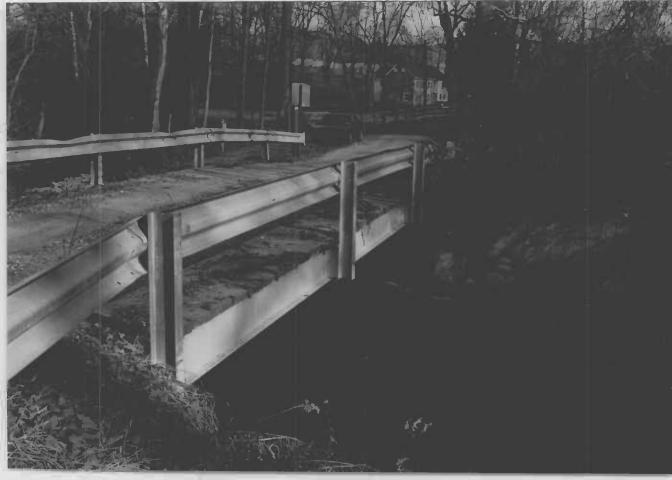
4/4

VIEW LOOKING NORTH
